New Zealand Disasters

Cave Creek

28 April, 1995

Where: Cave Creek, Paparoa National Park

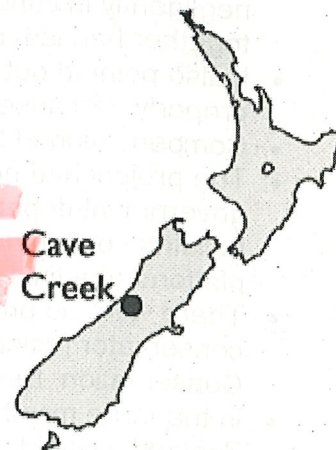
On 28 April 1995 17 members of a party of students from the Outdoor Recreation course at Tai Poutini Polytechnic at Greymouth and the Department of Conservation's Punakaiki Field Centre Manager crowded onto the viewing platform high above Cave Creek. The platform collapsed and fell about 30 metres into the resurgence below. As a result 14 young people lost their lives and the other four were injured, some very seriously.

- It was later found that the plans for the platform had been designed and approved by people who did not have engineering or design qualifications.
- The onsite construction of the platform base had been carried out by a working party of DOC staff members. None of the group working on the platform were qualified builders or engineers.

- The platform had been built and then flown in to Cave Creek by helicopter to be put in place, but the plans for the installation of the platform were not taken to the site, and so were not followed.

- The bolts which were supposed to tie the platform to the steps were taken to the site, but no drill, so nails were used instead.
- When the steps to the platform were poured some time later they were not secured properly to the platform. This concrete was supposed to act as a counter-weight for the platform to help hold it in place.

- Steel which was supposed to tie the platform to the counterweight had disappeared, and no other steel was ordered or used.
- A commission of inquiry found that the Department of Conservation had acted illegally and negligently in constructing the platform, and that there had been a series of mistakes that together had led to the collapse of the Cave Creek platform.
