# Geonet, 2017

## Kaikoura earthquake landslide

### Landslide mapping

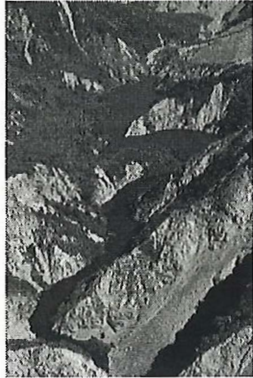
Conway landslide dam (photo: GNS Science)

Environment Canterbury and Marlborough District Council staff continue to monitor landslide dams that pose a risk to people or infrastructure downstream – this includes helicopter flyovers every few weeks and after heavy rainfall or strong aftershocks. At present monitoring is focussed on six dams that remain high risk – the Waima (Ure), Hapuku, Linton, Ote Makura, Conway and Stanton river dams. Other dams are also being monitored, but they are of lower risk: Two dams,
